**APOLLO 15 MISSION
ANOMALY REPORT NO. 1
MAIN PARACHUTE FAILURE**

APOLLO 15 MISSION

MAIN PARACHUTE FAILURE

Anomaly Report No. 1

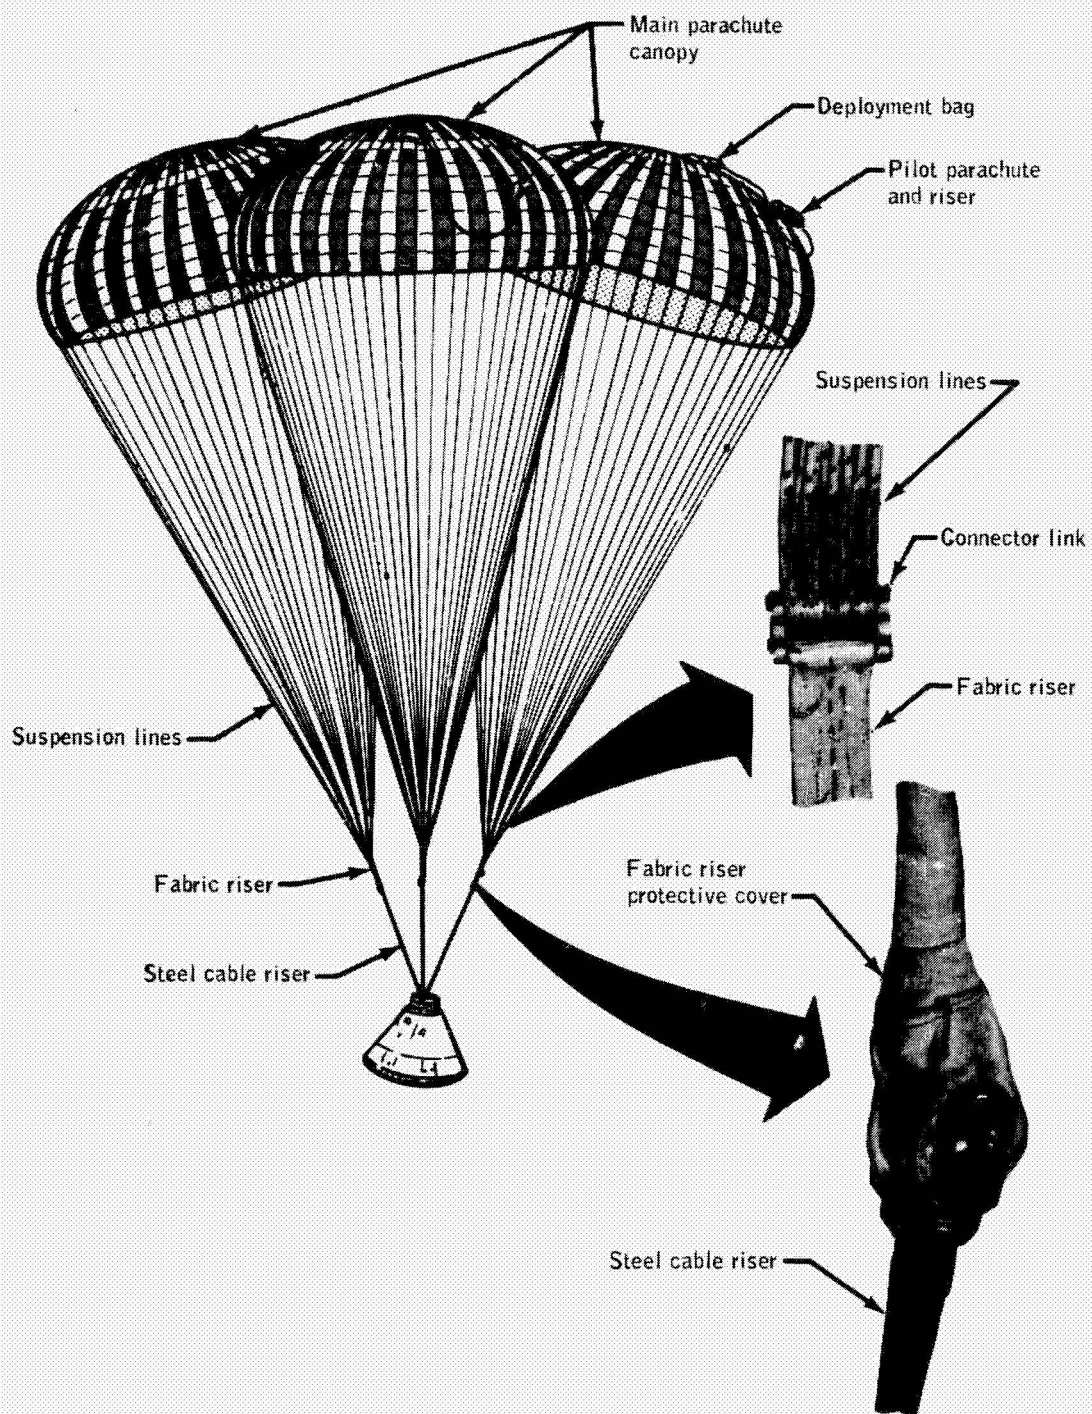
Figure 2.- Parachute system configuration.

lines which are attached by six steel connector links to six individual legs of a fabric riser. The six legs of the fabric riser converge into a single leg which connects to the end of a steel cable riser. The three steel cable risers of the parachute system converge and attach to the command module through the parachute attachment and disconnect assembly.
